Building Conditions Survey for The Bradley Palmer Mansion

at Bradley Palmer State Park
Topsfield, Massachusetts

Prepared by
Ocmulgee Associates Consulting Structural Engineering
and
Robert Carlson
for
Commonwealth of Massachusetts
Department of Environmental Management
Historic Curatorship Program
August 1995

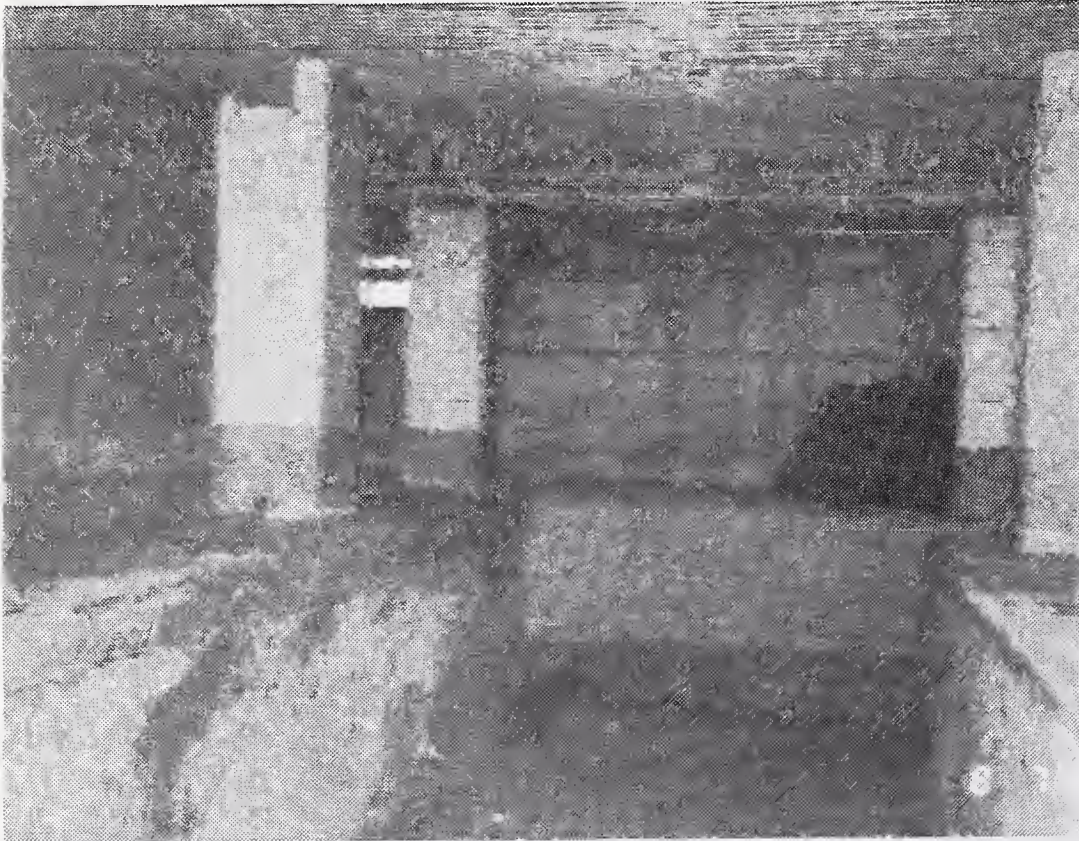
Deterioration has and is affecting concrete floor slabs directly exposed to weather. The patio slab over the "storage" room B06 (with the raised concrete shelf-like floors) is cracked and leaks. Efflorescence and minor spalling are visible along one of the cracks; corroded reinforcing steel is visible elsewhere; and surface scaling is occurring near a small hole in the slab. With a new membrane, the patio area could be easily repaired and stabilized.

The only area of deterioration in the foundations was at the low walkway walls in room B06 under the patio-like space next to the ballroom. Because the roof slab leaks and water stands on the walkway floor for considerable periods of time, the terra-cotta and plaster construction of the low walls has absorbed the moisture in a manner similar to the way brickwork is affected by rising damp. The plaster is decomposing and the terra-cotta is deteriorating (Figure 4). Apart for its function as a corridor between the original 1904 building and the later service wing, the purpose of this room and its patio-like roof are not obvious.

Figure 4. Room B06 Under Patio.
Note Deteriorated Low Wall On Left and Damaged Ceiling.

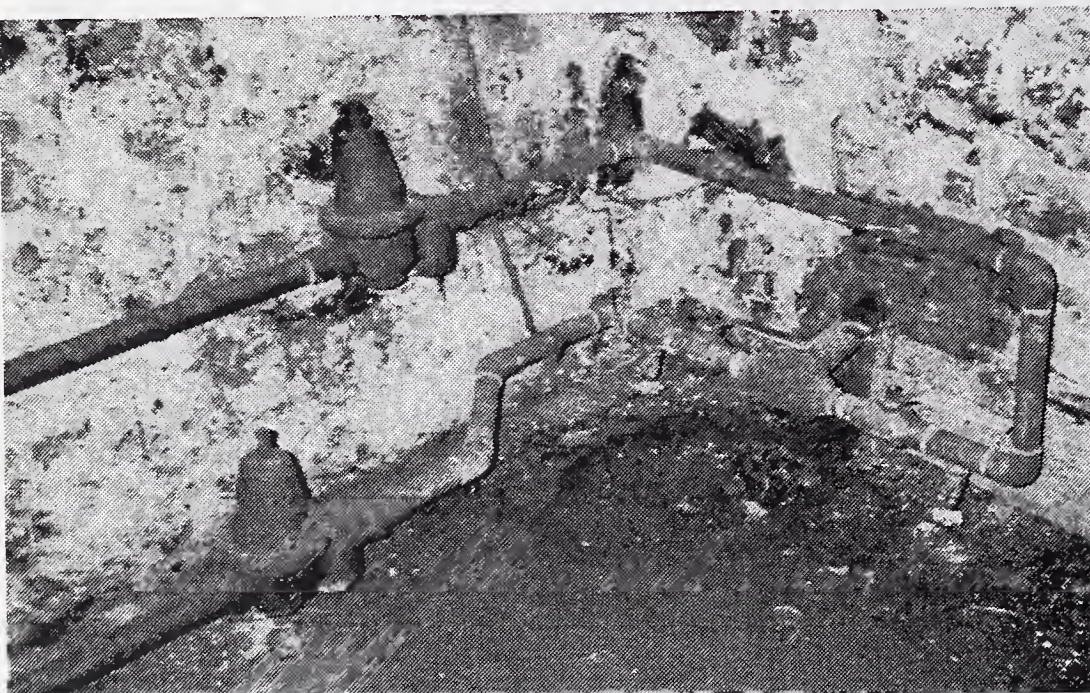
Water Works. After entering the building, the line splits into two 1-1/2 inch lines, each with a separate meter (Figure 5). Water supply piping inside the building is cast iron, copper and brass and ranges from fair to poor condition; several leaks and taped repairs were noted. Pipe insulation is in poor condition and is known to contain asbestos, according to a 1988 site survey by Dennison Environmental; it is missing or falling in several locations in the basement and crawl spaces due to excessive moisture and humidity (Figure 6).

Figure 5. Split Water Service.

All water supply piping and sanitary drainage piping should be tested, inspected and repaired or replaced; all pipe insulation should be replaced with new insulation. A new on-site sewerage disposal system should be installed. The water supply line should be replaced from the water main, which is near the park maintenance building south of the Carriage House and Stable.

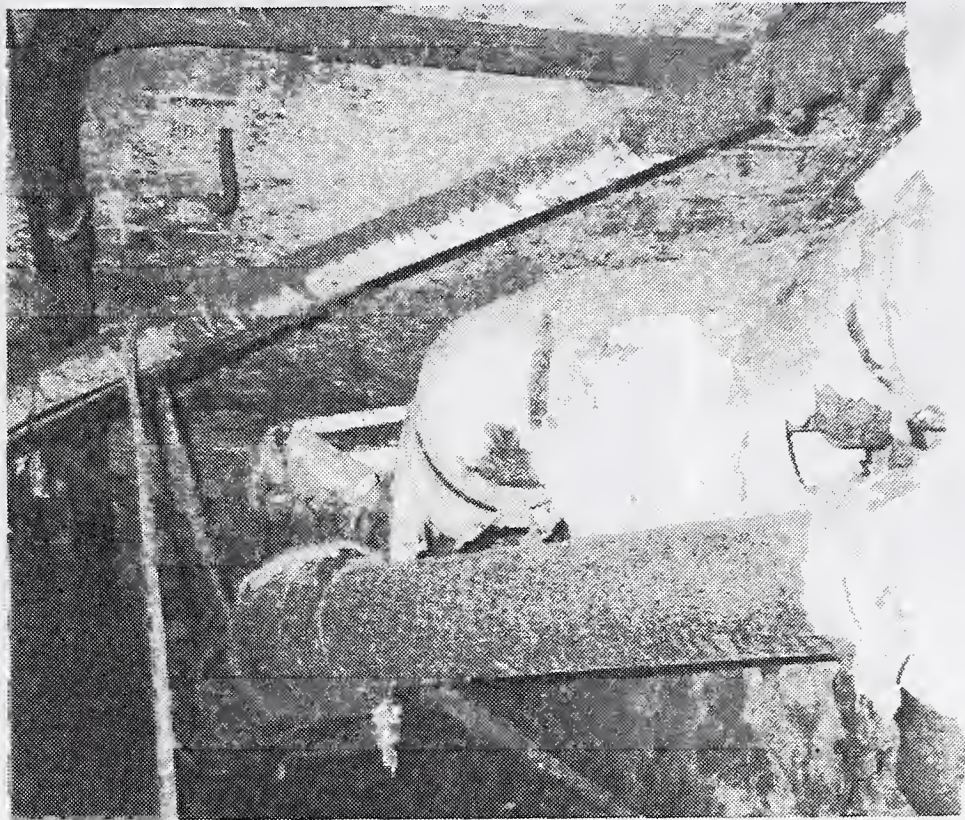
Figure 6. Torn Insulation and Uninsulated Pipe.

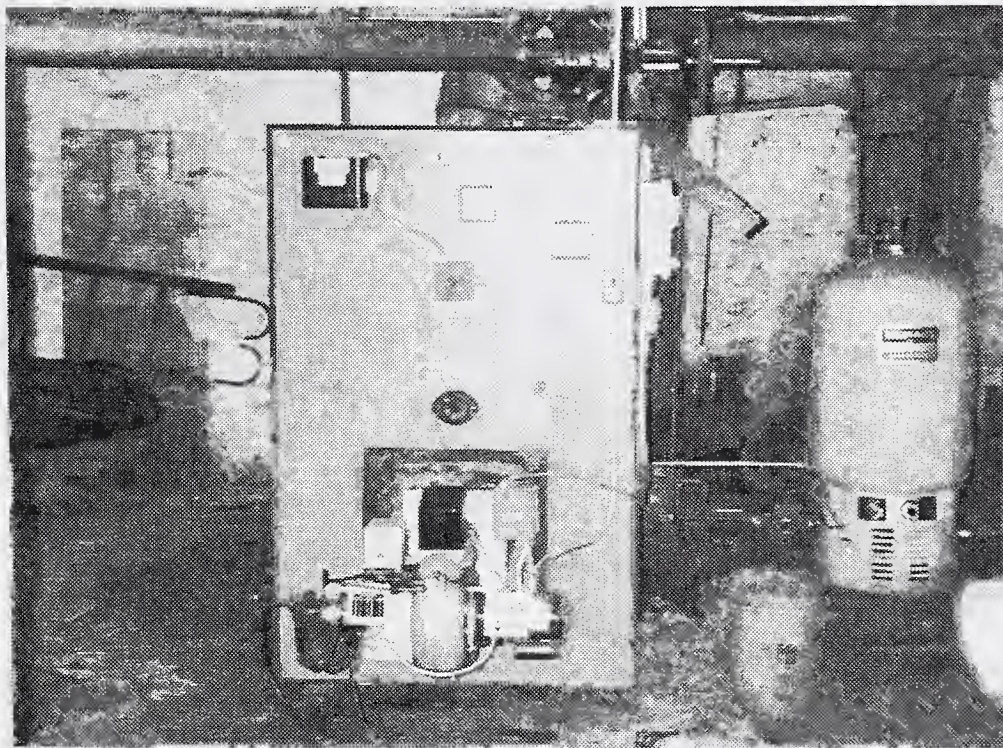
Central Heating System. A new Weil-McLain hot water boiler and Carlin Model 801 CRD oil burner (Figure 7) were installed in early 1990. The Model WM BL 889 WS cast iron boiler has a gross rating of 1,904,000 BTU's. The original gravity system was converted to forced hot water but the original eight inch mains are still being used. Copper fuel lines in the boiler room are embedded in concrete. The fresh air intake for boiler combustion is clogged with dirt and debris. At the same time the furnace was installed, non-electric flow valves were installed on most of the cast iron radiators to control the heating system. Some radiators, however, have been disconnected from the system.

Figure 7. Hot Water Heating System.

underground fuel tank should be removed and replaced; the copper fuel lines should be replaced; an air combustion louver meeting the building code should be installed; the boiler breaching should be replaced; and the heating system piping should be checked, repaired and insulated.

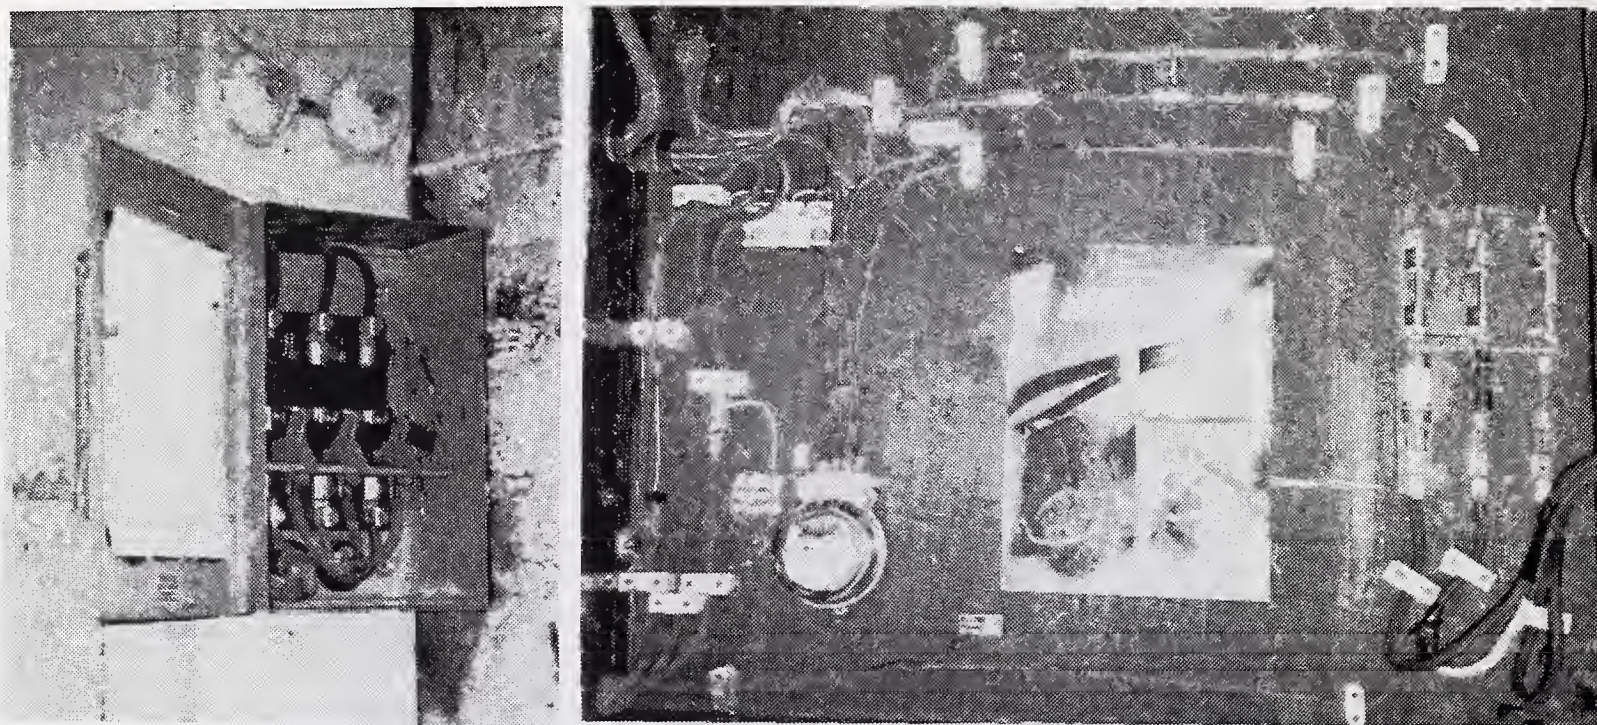
The existing electrical service has exposed, energized and accessible live components. The branch circuit panels are antiquated, live front panels with cartridge type plug fuses with no means of disconnecting them (Figures 8A and 8B). Electrical panels in occupied spaces are recessed into millwork; panels in the basement and crawl spaces are surface mounted and rusted due to prolonged exposure to moisture and high humidity. Inappropriate conditions that violate the building code include: wiring fused for a higher range than its rating; loose, hanging wires (Figures 8C and 8D); missing junction box covers; cartridge fuses with no means for disconnecting the service; and exposed live wires in areas accessible to unauthorized personnel.

Figures 8A and 8B. Antiquated Circuit Panels.

The present electrical system should be removed and replaced with a modern system complying the building code and adequate to serve the needs of any proposed new use for the building.

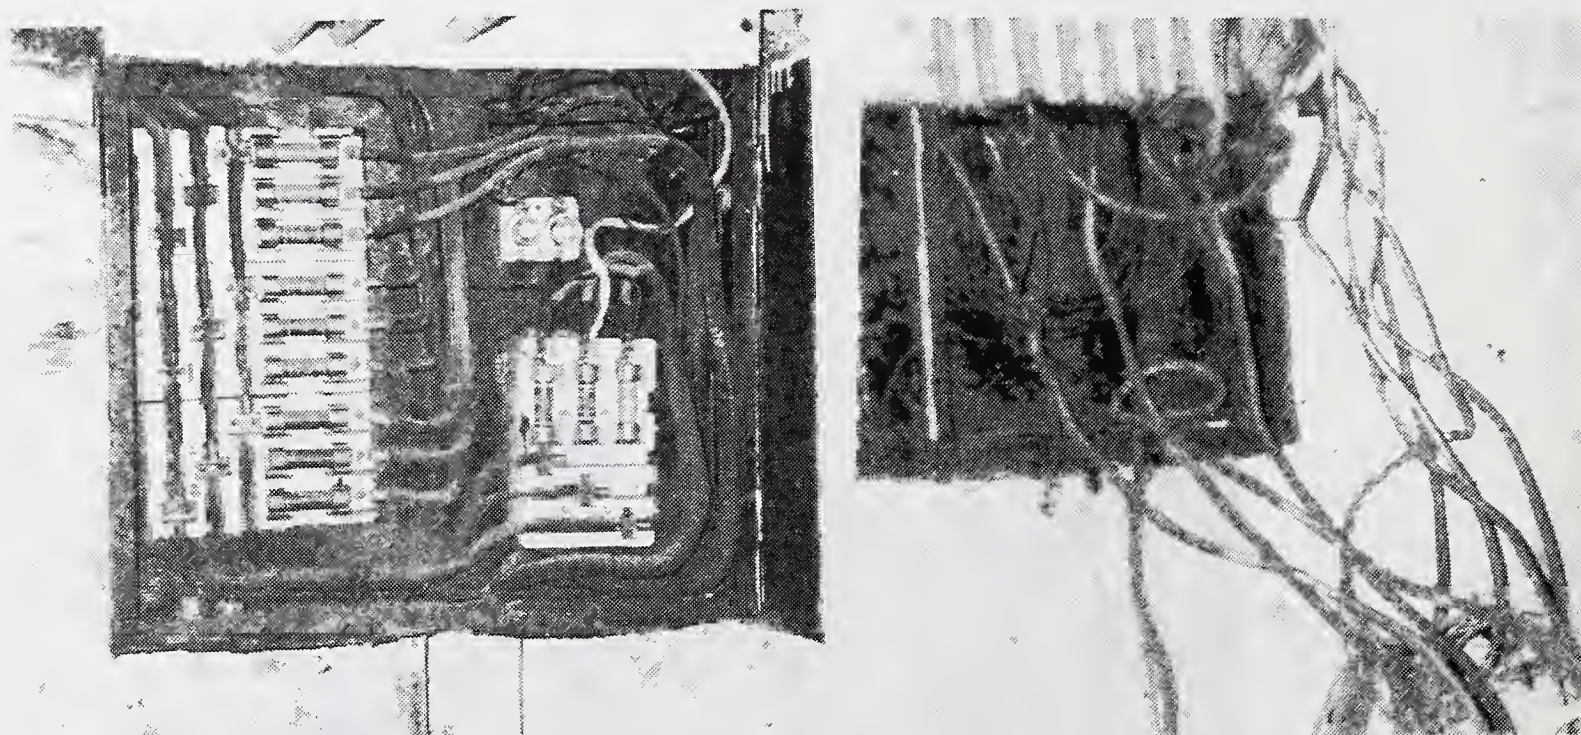
Figures 8C and 8D. Cartridge Type Fuses and Hanging Wires.

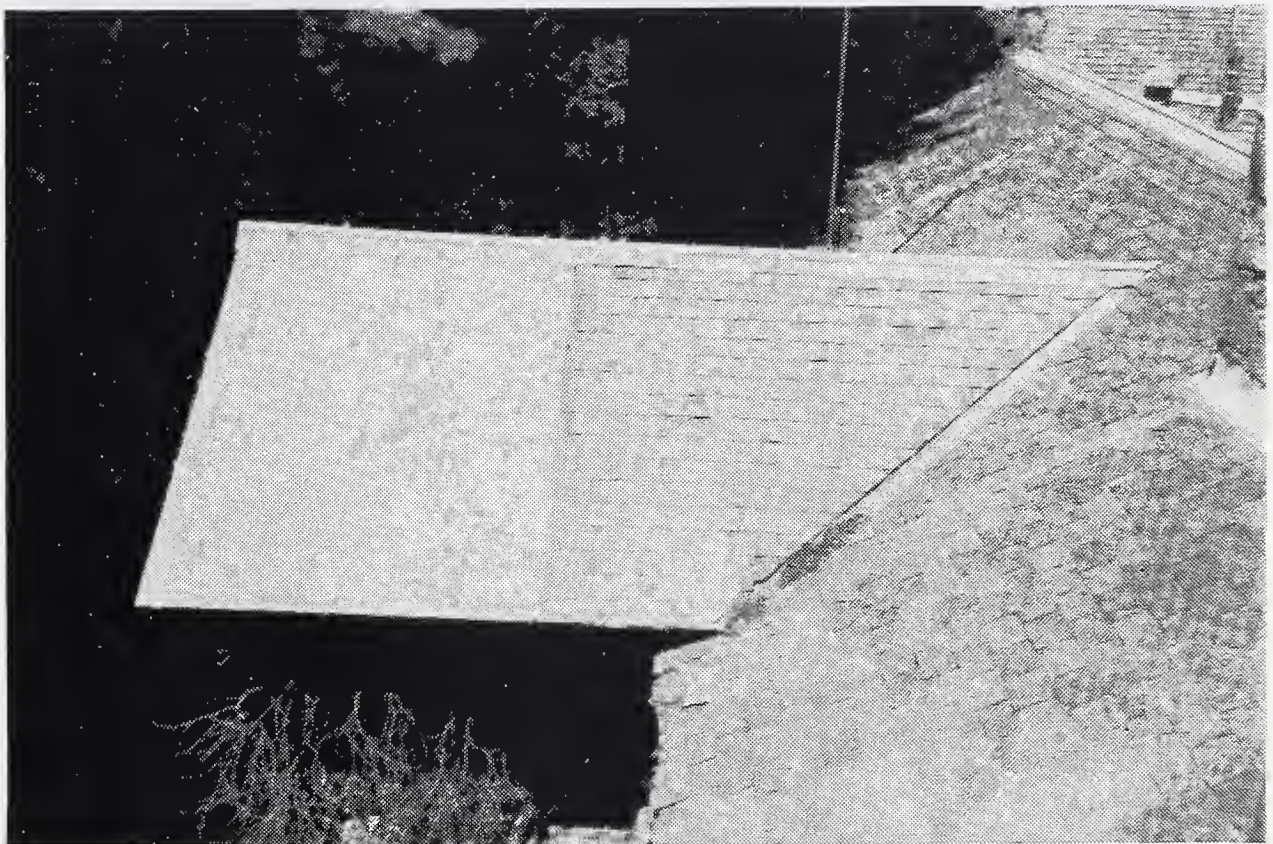
Figure 10. Asphalt Shingles on Left. Note Chipped and Cracked Slate.

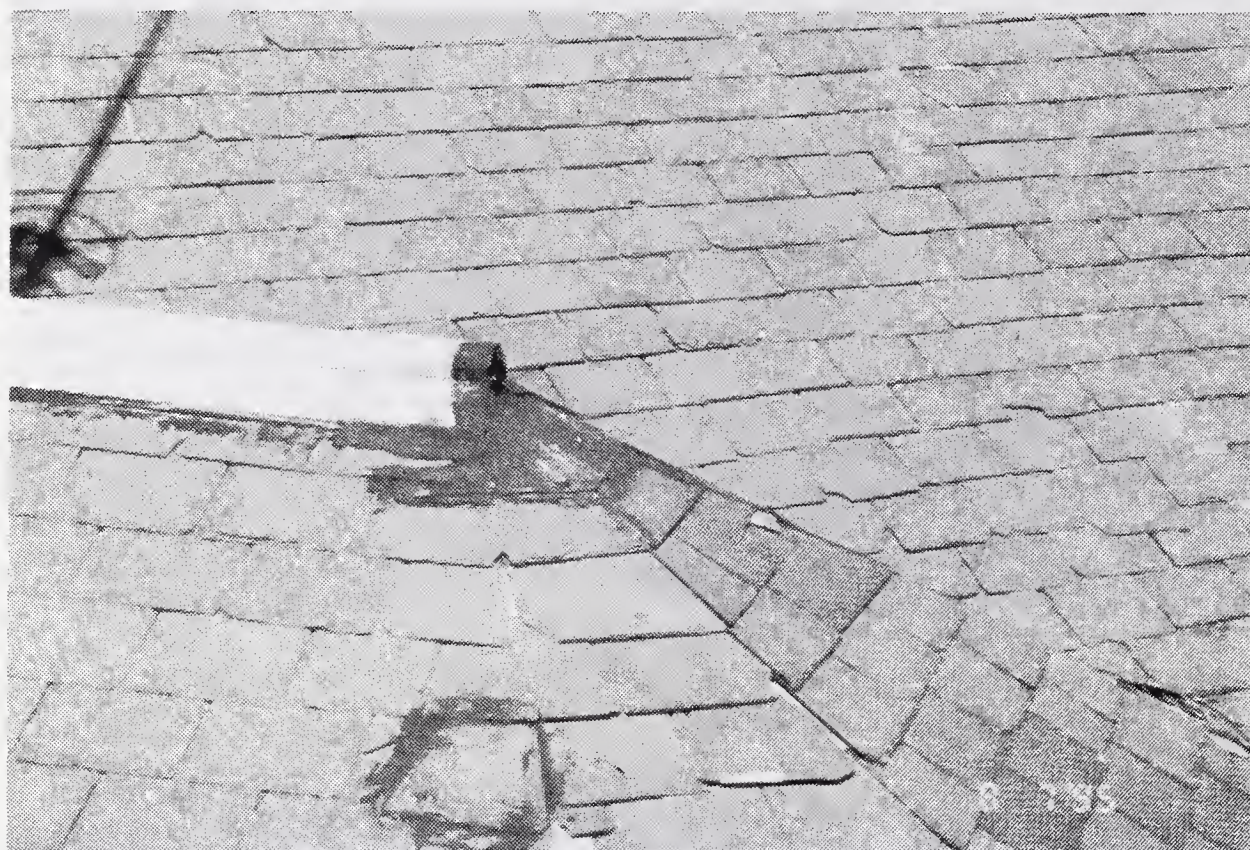
About 20 percent of the slate is cracked, broken or missing and needs to be replaced (Figure 11). Copper cap flashing over the slate is loose in several areas and needs to be refastened. Valley flashing is severely deteriorated in many locations and sheathing is visible through holes in the flashing (Figure 12).

Figure 11. Past Repairs and Existing Condition of Slate Roof

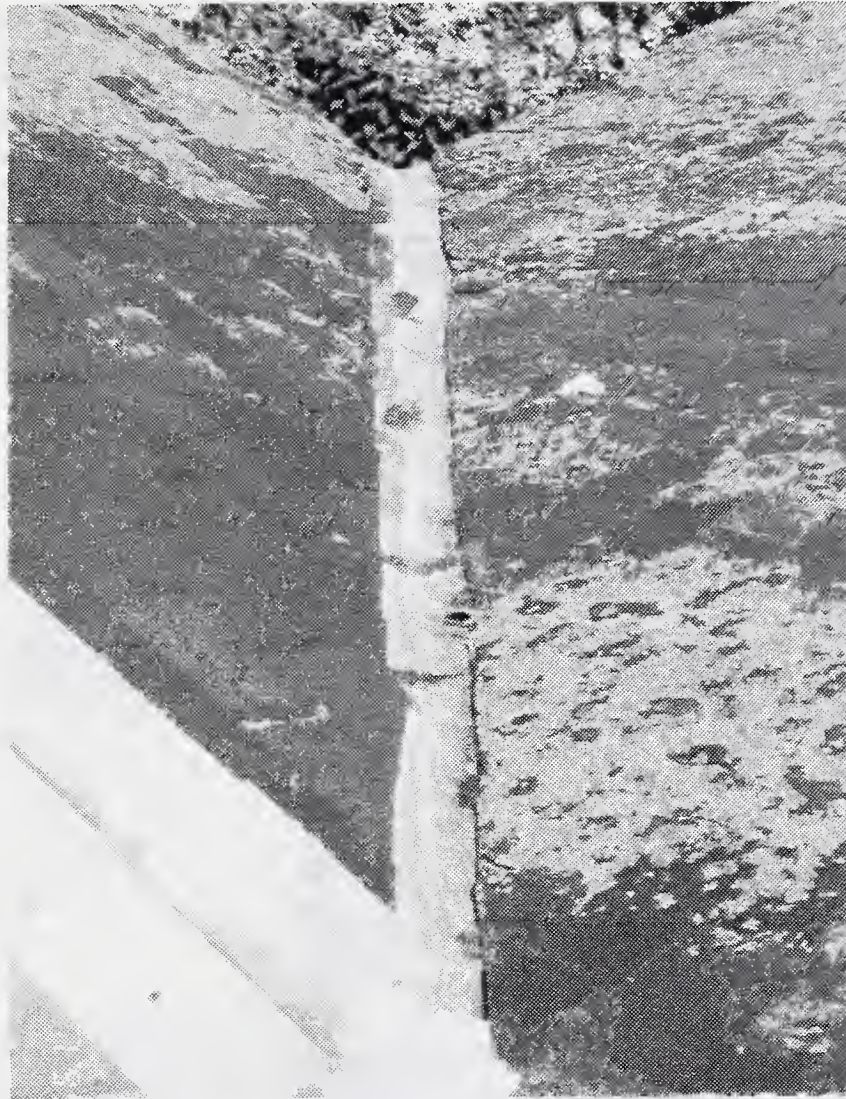
Figure 12. Damage Valley Flashing. Note Hole Half Way Down the Flashing.

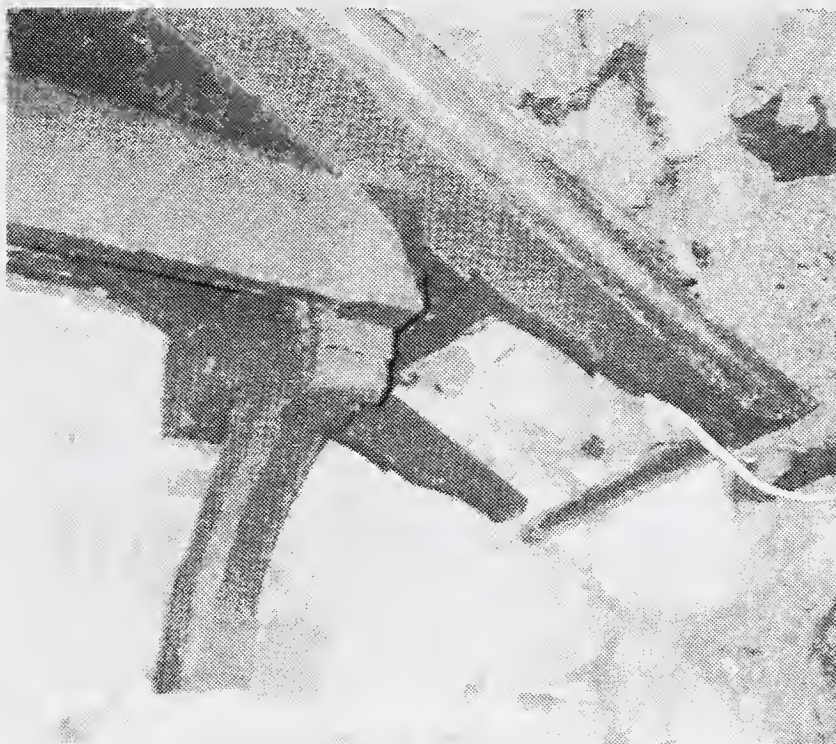
Three of the doors are sheltered by porch roofs that cantilever from the building wall. These are in good condition although the one over the side door at the main entrance is missing a section of roof boards on the right hand side (Figure 13).

Figure 13. Decorative Bracket and Rafter Tail. Note Missing Soffit Boards.

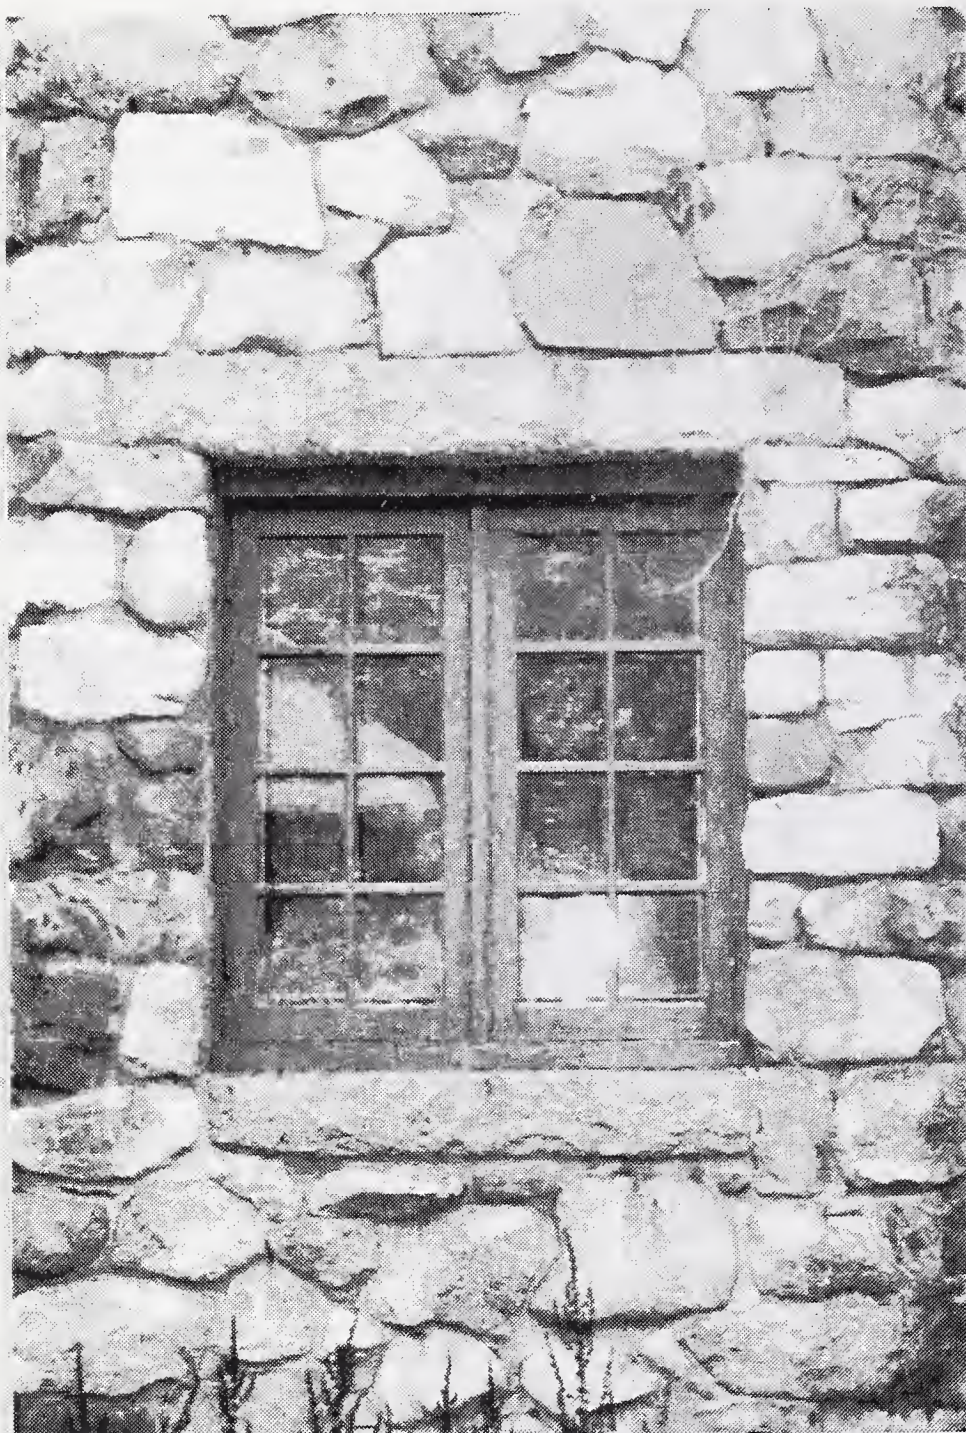
Walls. The exterior stone-faced walls are in excellent condition in spite of past coverage by vines (Figure 14). Random, narrow cracks occur in the mortar joints but are not unusual for this type of construction; there are no displacements in the stonework. Although the vines have been cut down, large roots are still embedded in mortar joints on the front of the building. At these root locations and at a relatively small number of other locations, the joints should be cleaned, cut back and repointed. In the back of the building, the vines have reestablished themselves. To the extent that these vines may have been planted by Bradley Palmer, they should be pulled away from the building and trained onto new trellises. Because of the rapid growth of vines, they will need constant pruning to prevent them from engaging the building fabric. To the extent that

Figure 14. General Condition of Stone-Work and Windows.

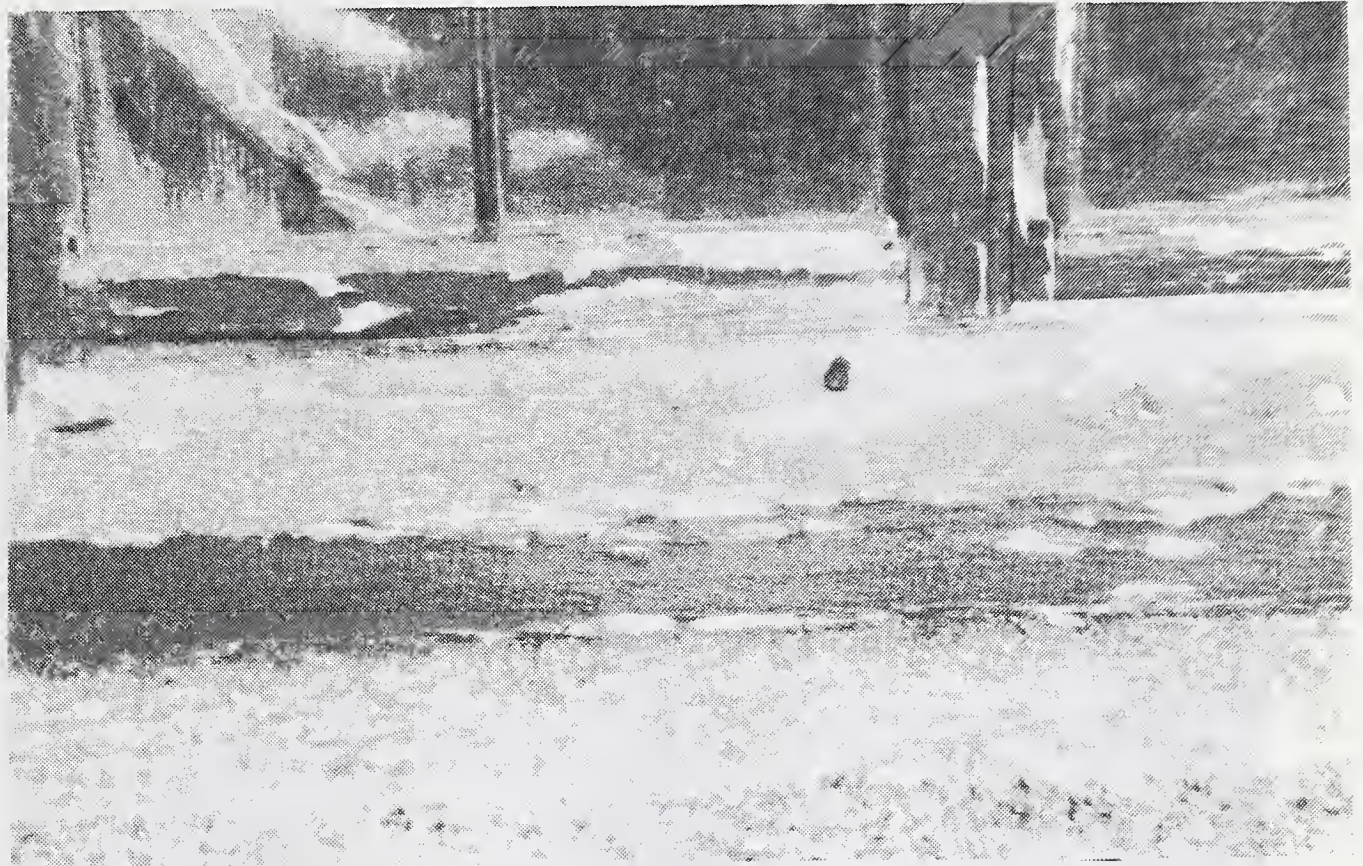
Figure 15. General Condition of Window Sills and Glazing Compound.

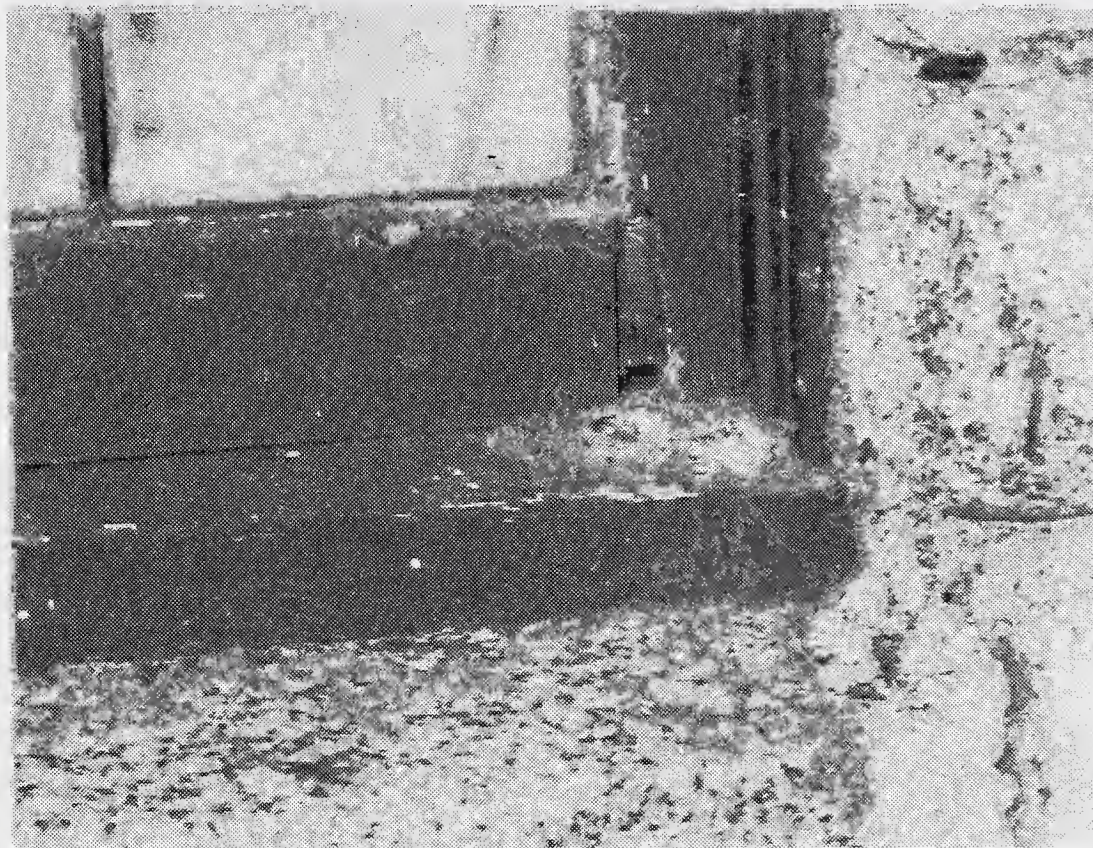
The sash at the ballroom and dining rooms differs from that at the rest of building insofar as it does not have any wood muntins or bars. Rather, it supports an assembly of leaded glass that fills the whole opening of the sash. As a result of having less material to hold the rails and stiles together, the windows at these rooms are badly sprung and, in one instance at the ballroom, a rail and stile have broken apart (Figure 16). Around the corner from this

Figure 16. Broken Corner at Ballroom Sash.

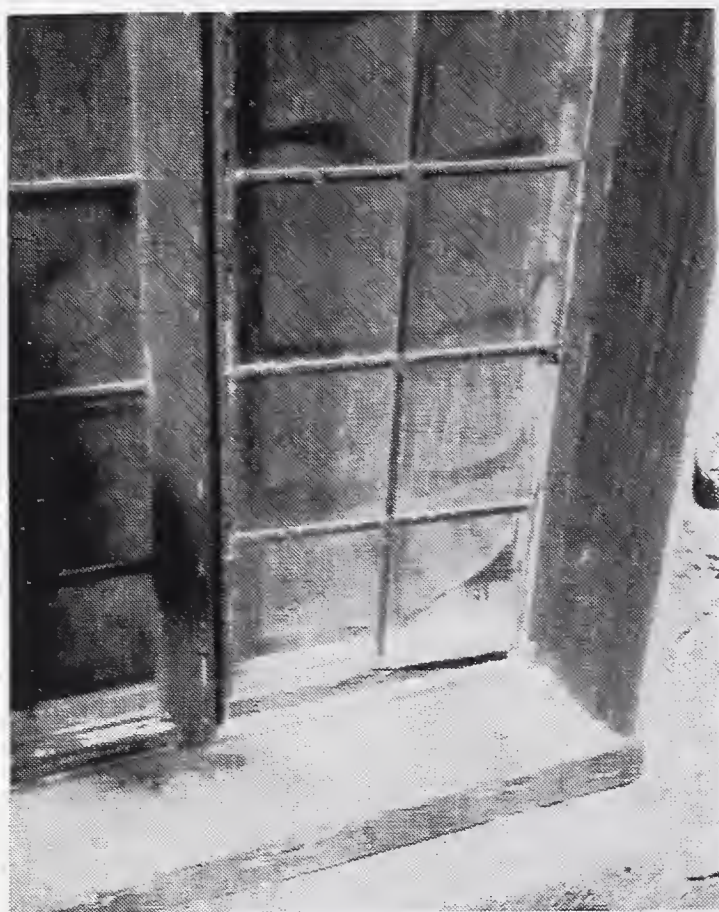
Figure 17. Twisted Leaded Glass Panel in Ballroom Sash.

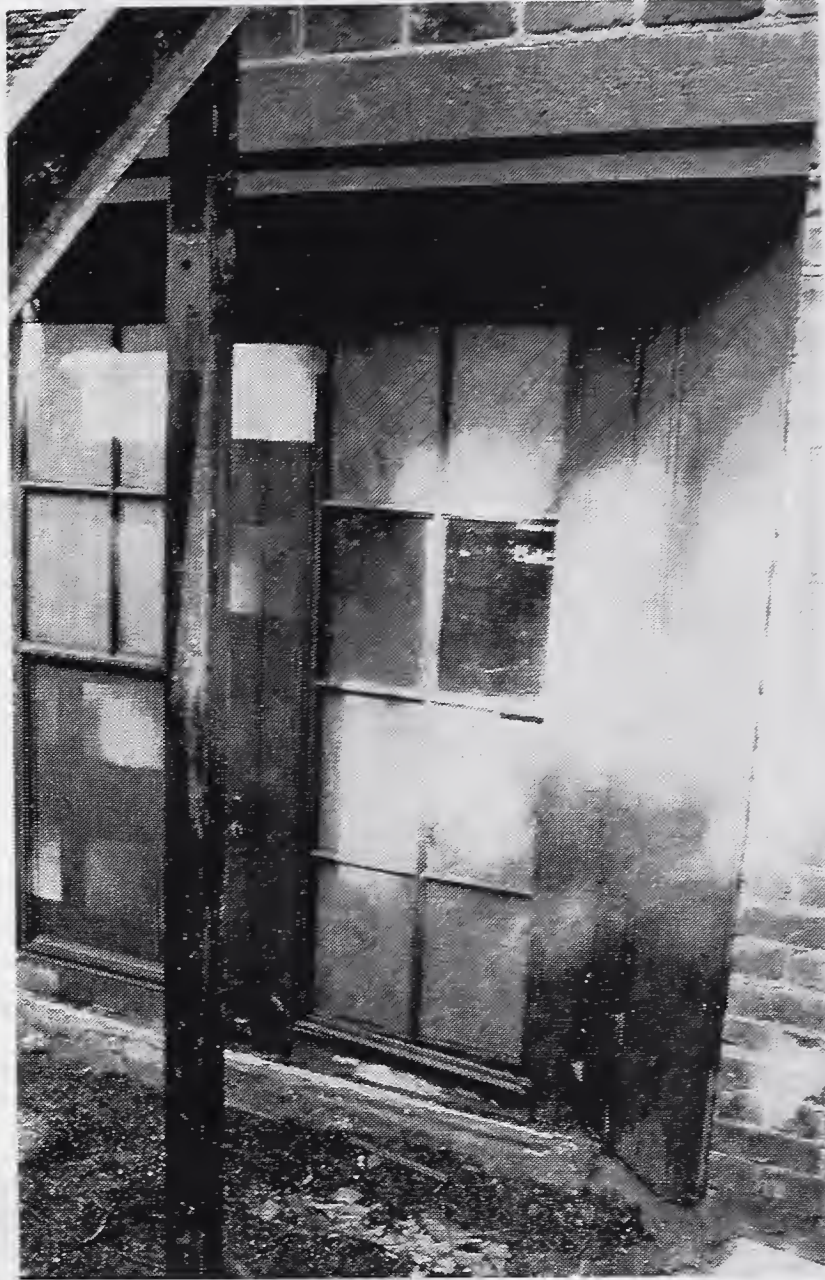
Doors, Entries and Porches. Although all of the doors and their casings are worn and in need of refinishing, only one of the nine exterior doors is actually badly damaged (Figure 18); there are also two sets of double-leaf French doors, similar to the windows in construction. The badly damaged door is in the first floor service corridor and opens out onto the patio-like area; it appears to have been vandalized.

Figure 18. Damaged Door and Flashing at Ballroom Patio.

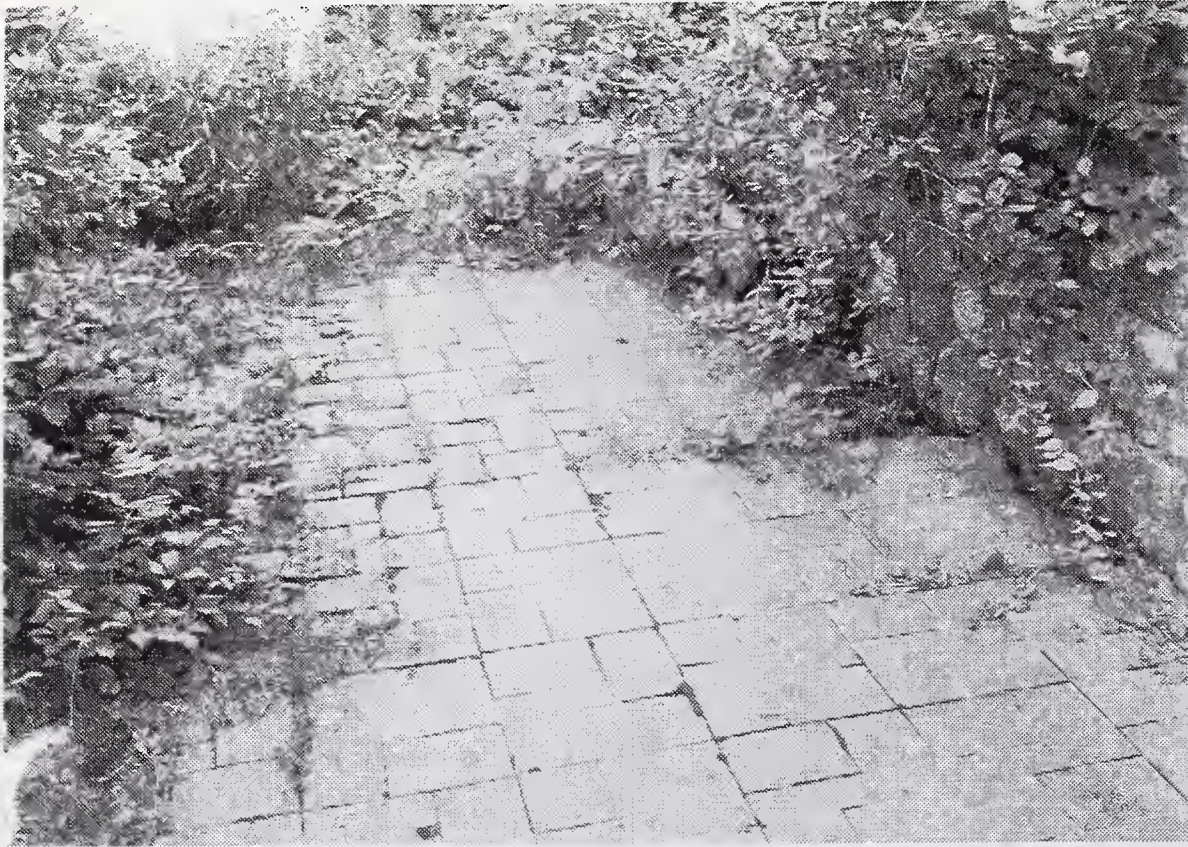
Figure 19. Overgrown but Relatively Undamaged Clay-Tile Patio.

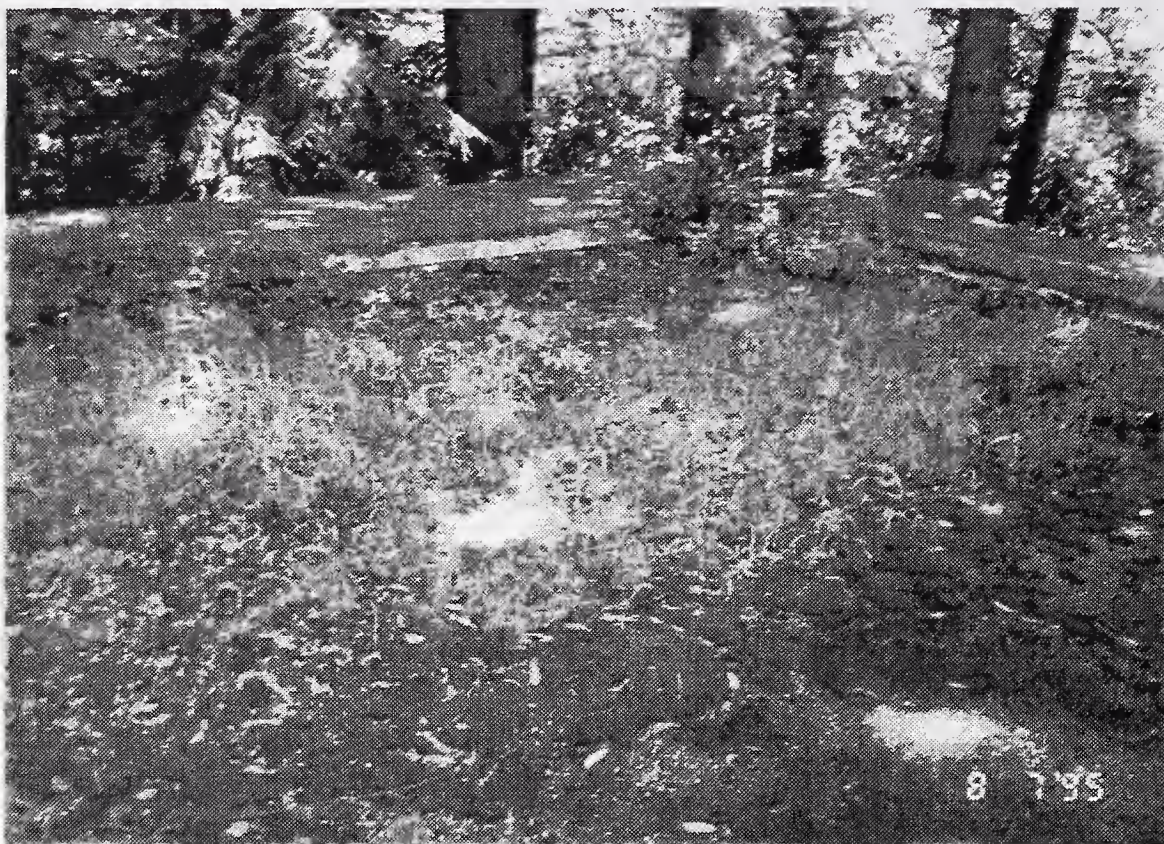
Figure 20. Overgrown and Heavily Damaged Tar-and-Gravel Covered Ballroom Patio.

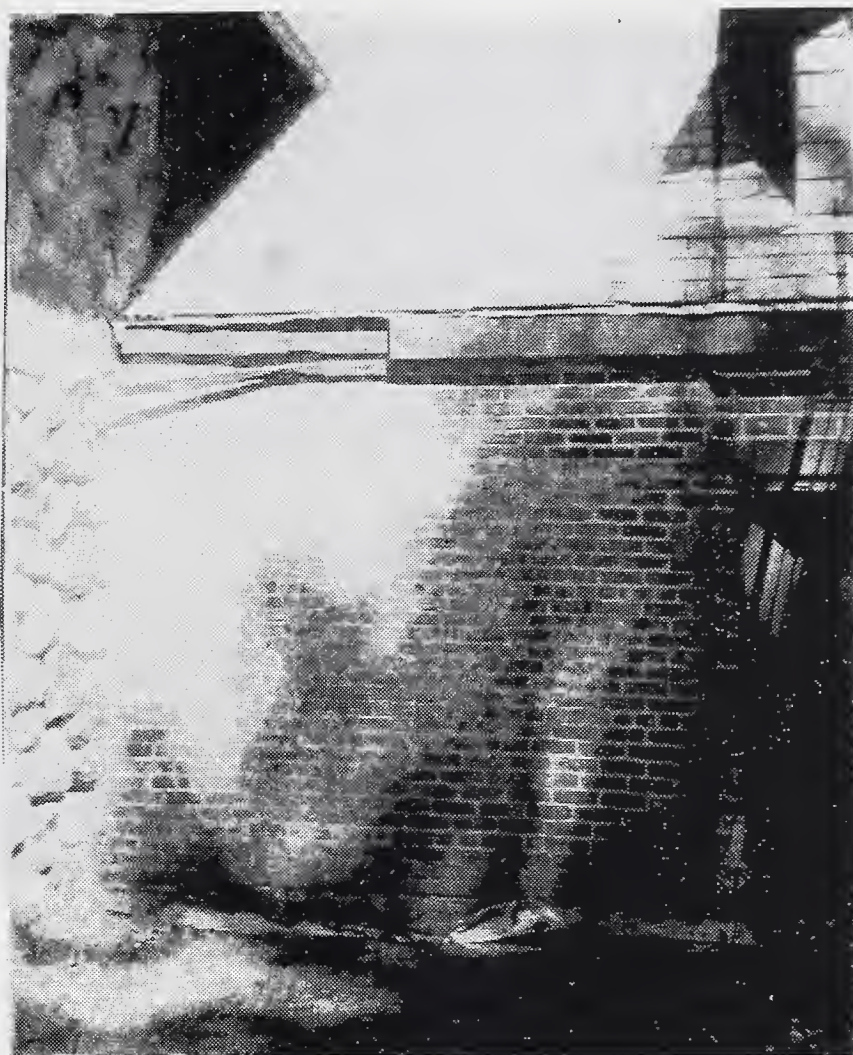
The purpose of the patio-like area outside the ballroom is not readily apparent. Although it seems to be an open air extension of the ballroom, its overall location without a vista, the low, dangerous parapets, its direct access to the service corridor, and its location below the servants quarters all suggest a less-than-formal function. As indicated above, the tar-and-gravel roofing over the patio slab is completely deteriorated (Figure 20); likewise, the flashing between the building walls and this roofing is torn, loose and missing. This deteriorated flashing has allowed extensive water infiltration through the walls, resulting in damage to the interior finishes. The only exterior brick wall on the entire building occurs along one side of this patio; the upper six or seven courses appear to be a different type of brick than the lower part of the wall; the trim boards at the roof eave appear to have been rebuilt several times, often ineptly (Figure 21). It is not apparent why this wall is not clad in stone.

Figure 21. Brick Wall at Ballroom Patio.
Note Defective Fascia Boards and Flashing at Base of Wall.

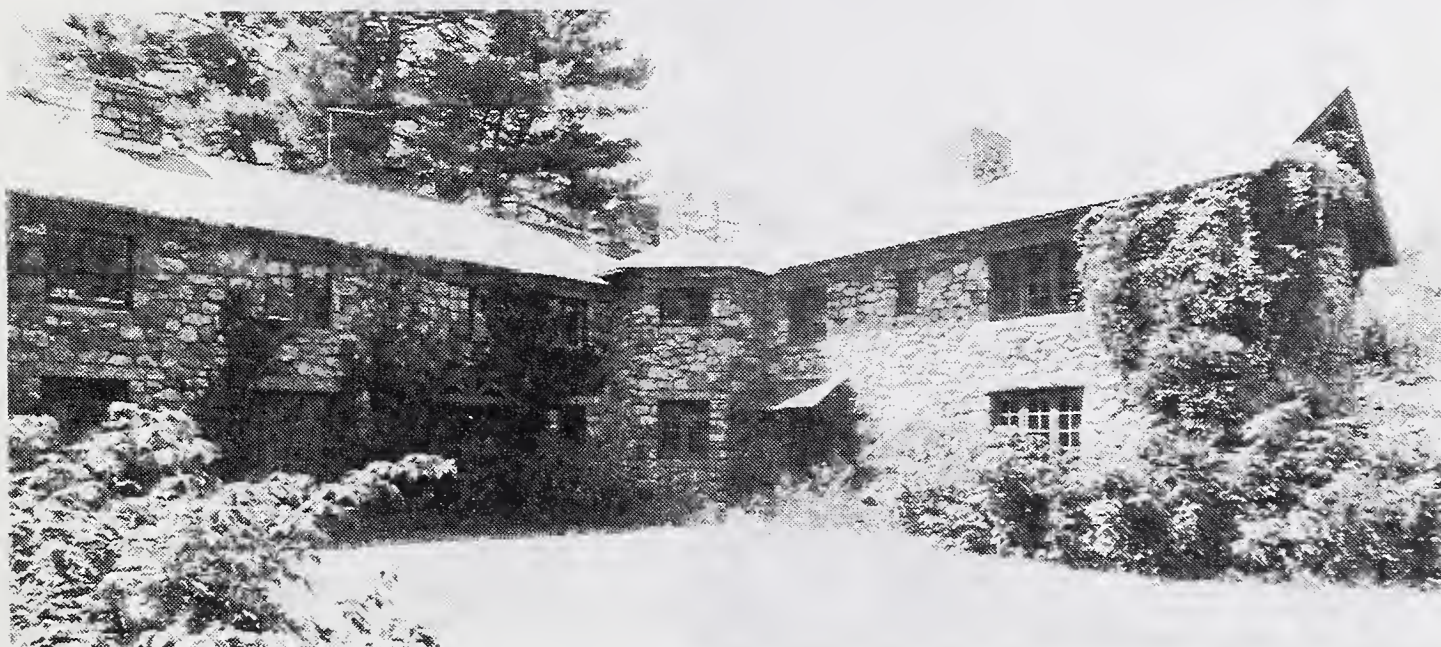
Figure 22. Overgrown Vegetation at East Courtyard.

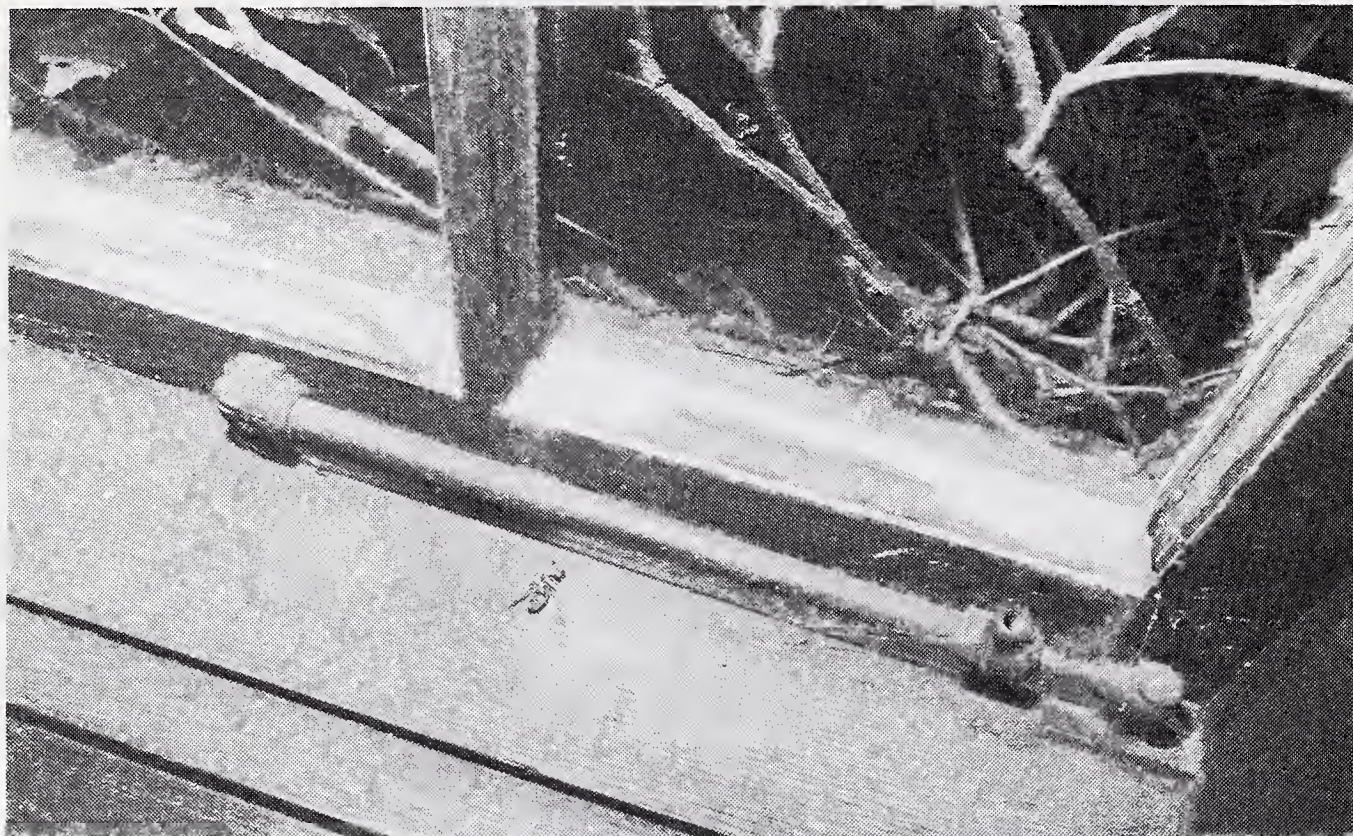
Figure 23. Typical Window Swing Hardware with Missing Clamp.

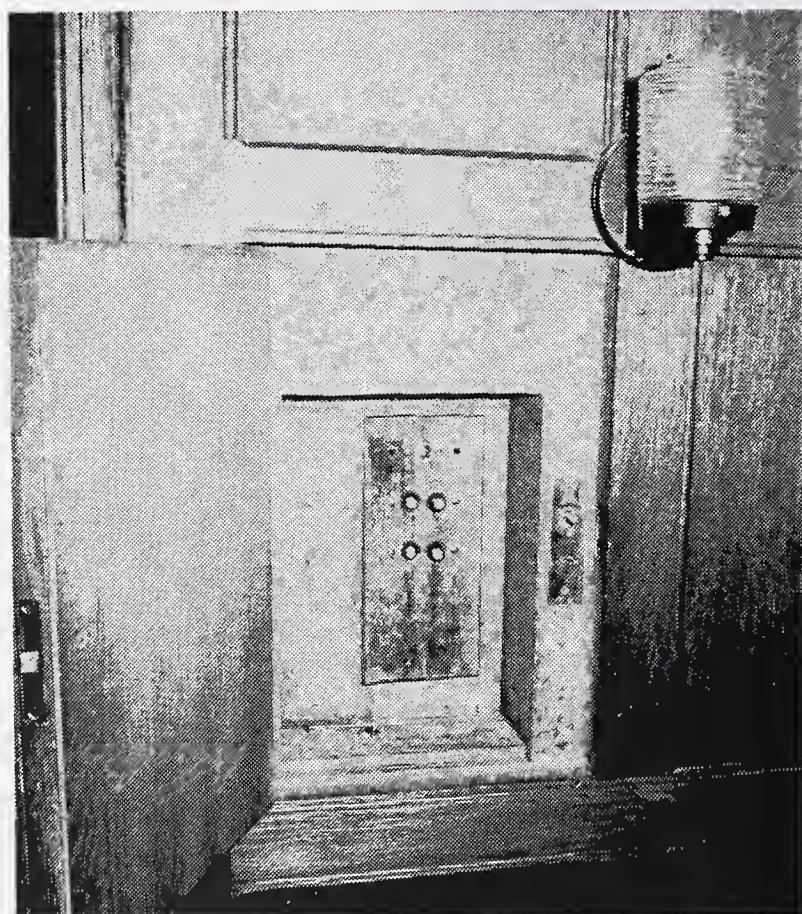
Figure 24. Button-Type Light Switches in Concealed Panel and Modern Light Sconce.
